City of Baltimore Wet Smoke and Dyed	Page 1 of 2	
Sewershed: Gwynns Falls	Company: Savin	Date: 4/23/2009
Test to be performed: Smoke Dyed Water X	Ground Condition: Dry ☑ Damp ☐ Wet ☐	Supervisor: JAW
Manhole_ID: S01CC1002MH	Test ID: <u>D1032-026011</u>	Notification Made: NA (Residents, Fire, 311)

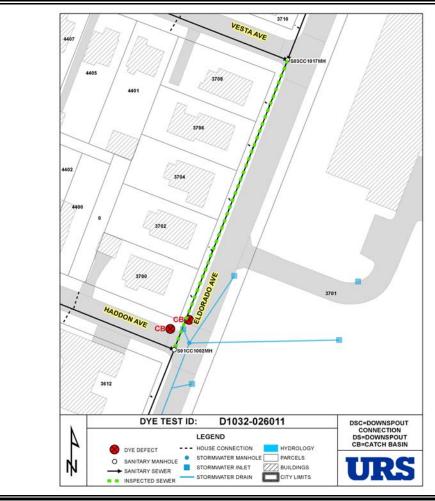
Field Sketch: Show all manholes with Numbers, Blower Placement Locations, Sandbag or Isolation Locations, Street Names, Building Addresses and Locations, Defect Locations and Photo Numbers.

Defect Loc	Obs_ClockFrom	Obs_ClockTo	Observation	Obs_Remarks
0			Start of Survey	
0			Water Level	
0			Manhole	S01CC1002MH
18.29999924			Dye Test Visible	@ IR, 0.1gpm
20.70000076			Dye Test Visible	@ IR, 0.2gpm
26.39999962			Dye Test Visible	@ IR, 0.5 gpm
29.5			Dye Test Visible	@ IR, 0.2gpm
32.29999924			Dye Test Visible	@ IR, 1gpm
41.79999924	06		Broken	
41.79999924			Dye Test Visible	@ B, <0.1gpm
45.09999847			Abandoned Survey	DYE FLOOD COMPLETED
